# The Effect of Repair/ Rewinding on

## Premium Efficiency/IE3 Motors

### Full Report\*

# Part 1: 2019 Rewind Study—The Effect of Repair/Rewinding on Premium Efficiency/IE3 Motors

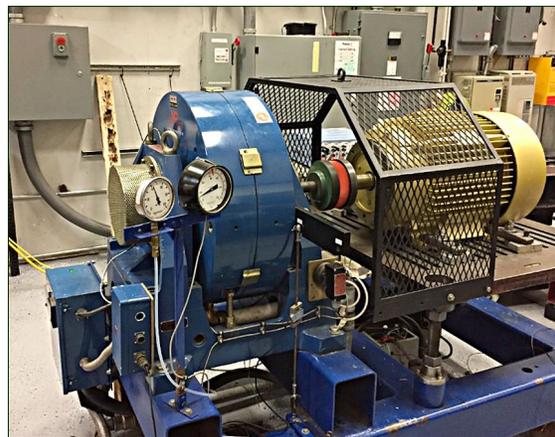
**Figure 1-1. Motor being dynamometer tested at Advanced Energy.**

Each motor was initially operated at rated load until steady-state temperature conditions were established and then load tested for motor efficiency per the IEEE Std. 112B.

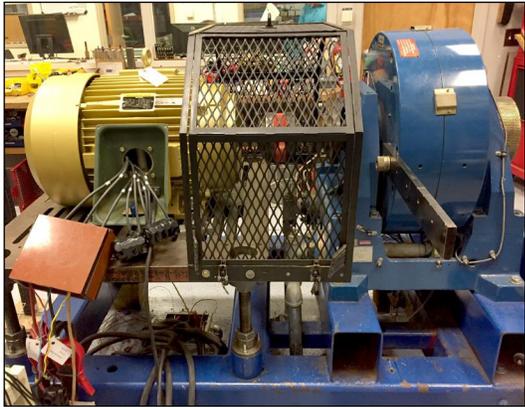
Figure A1: Motor heat run test on dynamometer in test laboratory.

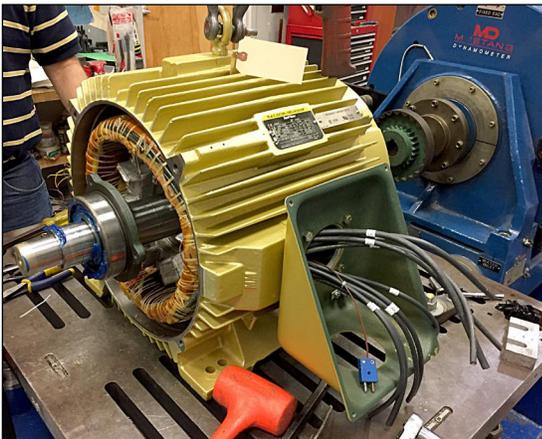
Figure A2: Partial motor disassembly to insert winding thermocouple.

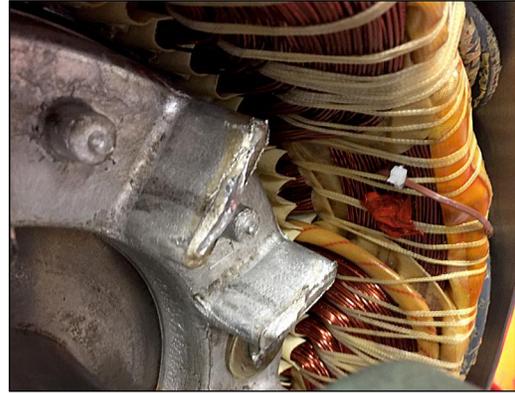
Figure A3: Partial motor disassembly to insert winding thermocouple.

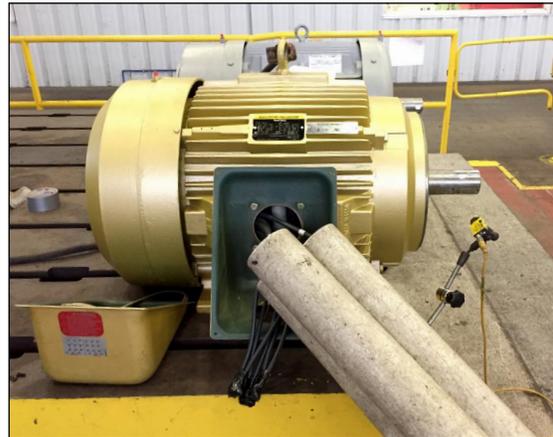
Figure A4: Incoming no-load test in service center.

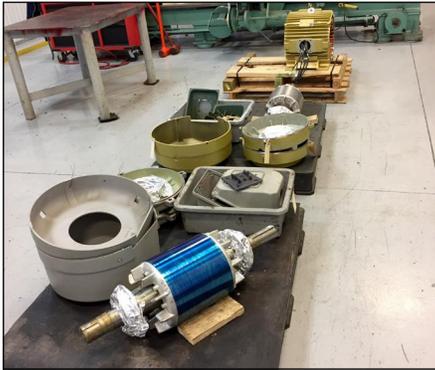
Figure A5: Disassembled parts line up.

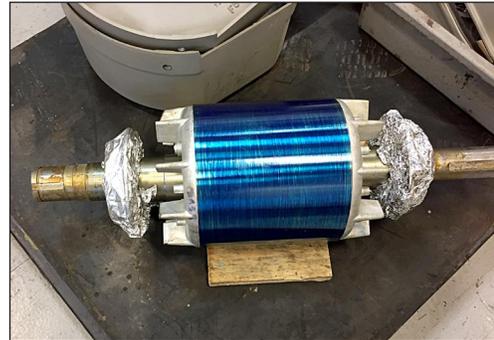
Figure A8: Rotor bearings wrapped to protect bearings and retained grease.

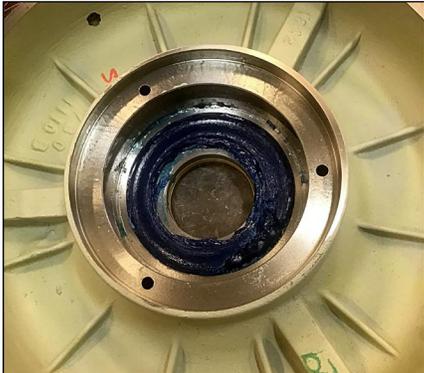
Figure A6: Lubricant retained in end bracket.

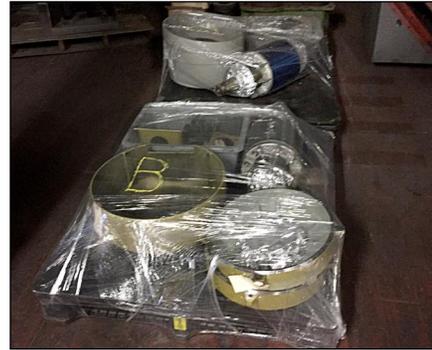
Figure A9: All mechanical parts in climate-controlled storage.

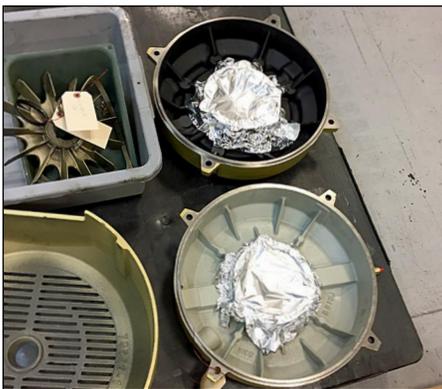
Figure A7: End brackets wrapped to protect retained grease.

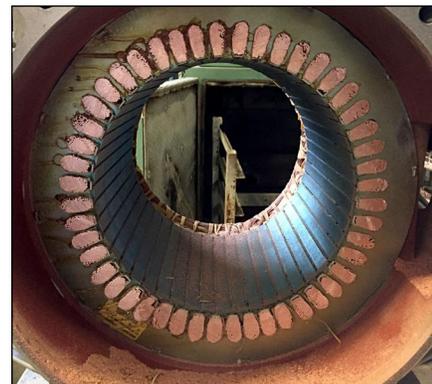
Figure A10: Stator winding extension cut off in preparation for burnout process.

All stators were burned out with a controlled part temperature limit of 700°F (370°C). Other specific controls applied to stators included control of core cleaning methods and rewind details such as turns/coil, mean length of turn, and conductor cross section. The benefits of these controls are described in the *Good Practice Guide to Maintain Motor Efficiency*.

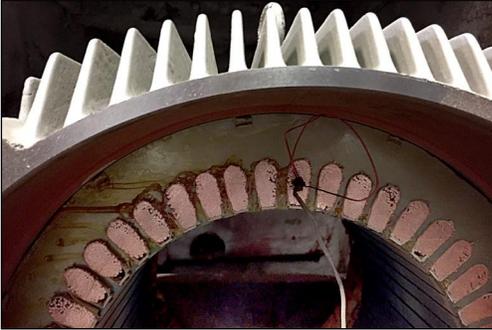
Figure A11: Stator temperature sensing probe installed.

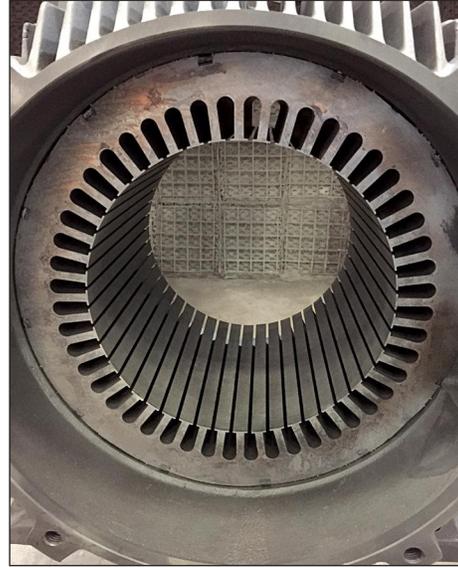
Figure A14: Stator cleaned after windings removed.

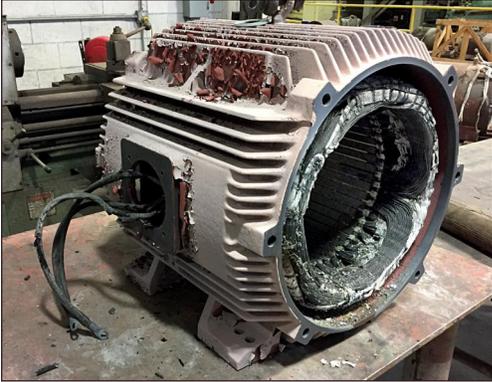
Figure A12: Stator winding post burnout process.

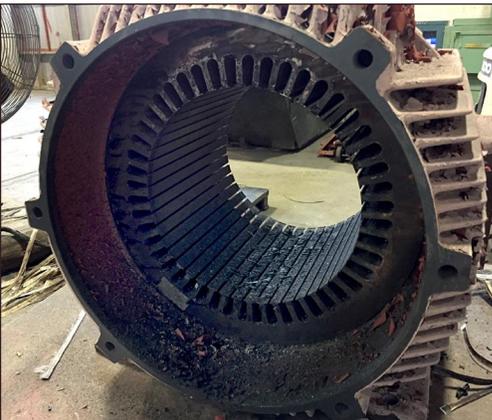
Figure A13: Stator with windings removed.

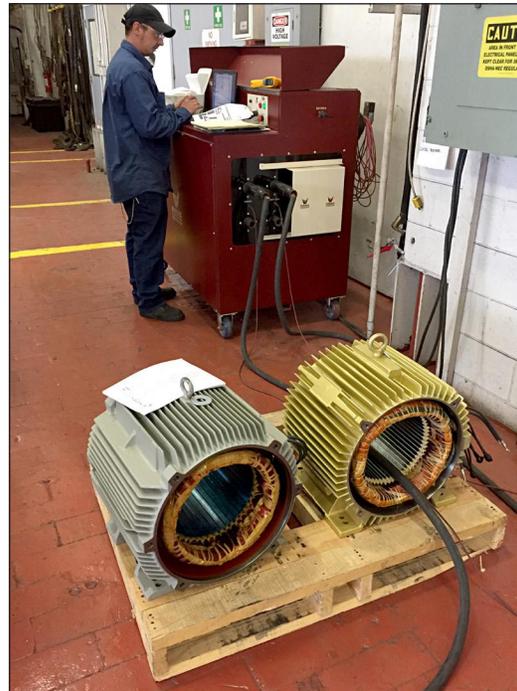
Figure A15: Stator core loss test.

In all cases core losses were measured before burnout and after coil removal using a commercial core loss tester at the motor service center. To minimize performance changes due to factors other than normal rewind procedures, bearings were not replaced, lubricant was not changed, and rotors were not balanced. All repair steps followed the good practices established in ANSI/

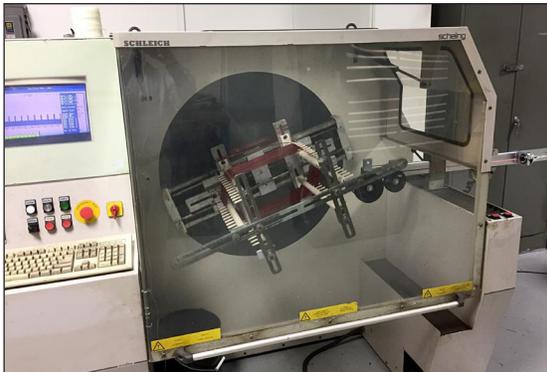
Figure A16: Stator coils being wound.

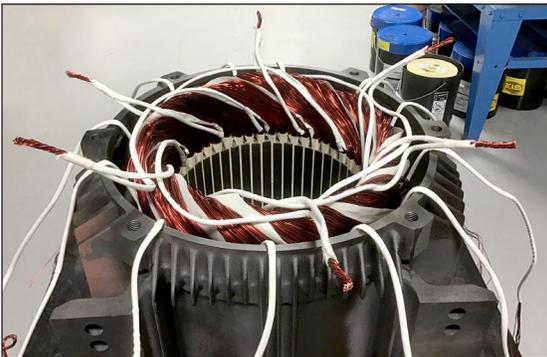
Figure A17: Stator connections being made.

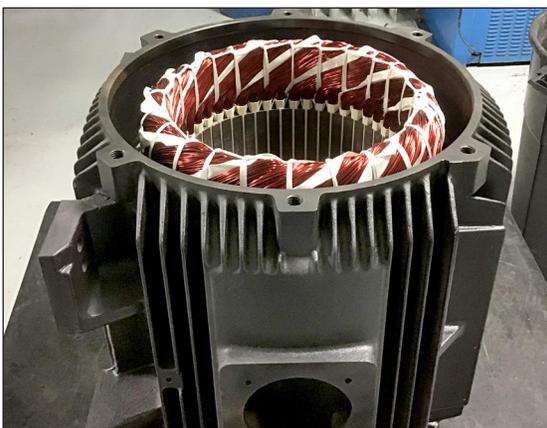
Figure A18: Stator opposite connection tied down.

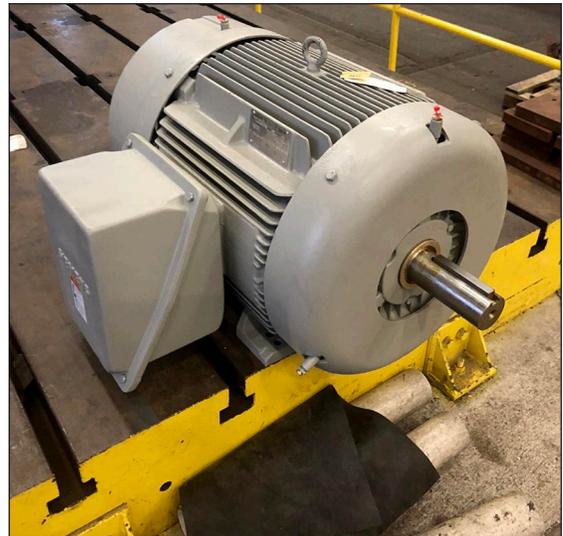
Figure A19: Motor after outgoing run test in service center.

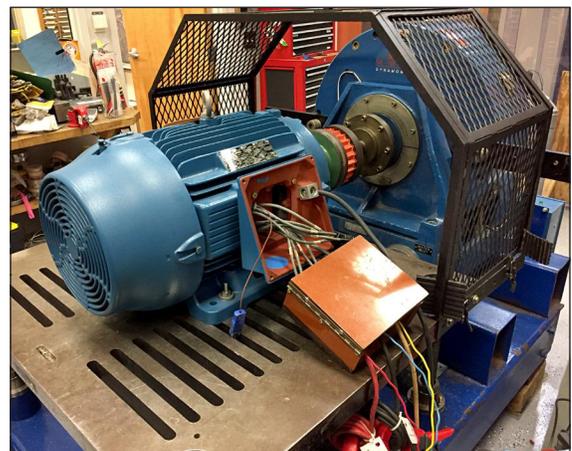
Figure A20: Motor prepared for post-repair efficiency test.

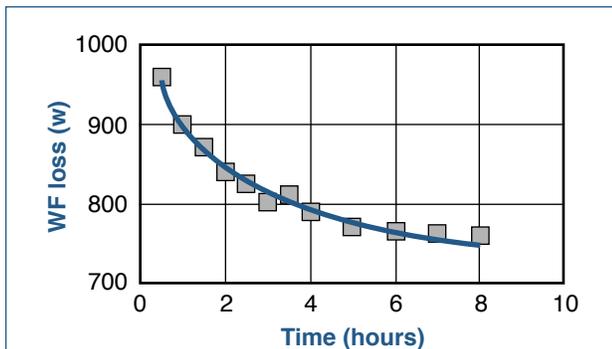
**Figure 2-2. Reduction in F & W losses during the break-in run for a 60 hp (45 kW) motor with proper grease fill tested in the 2003 rewind study.**

A number of studies have found that over-greasing the bearings can increase friction losses. For the study, grease was added to the bearings of two rewound test units in Group A. No change in lubrication was made on the rest of the motors in the test. As expected, bearing friction on the regreased motors increased and efficiency dropped 0.3 to 0.5 percent. Figure 2-2 (Page 2-8) illustrates the decrease in losses over time for a properly lubricated 60 hp (45 kW) motor in the study.

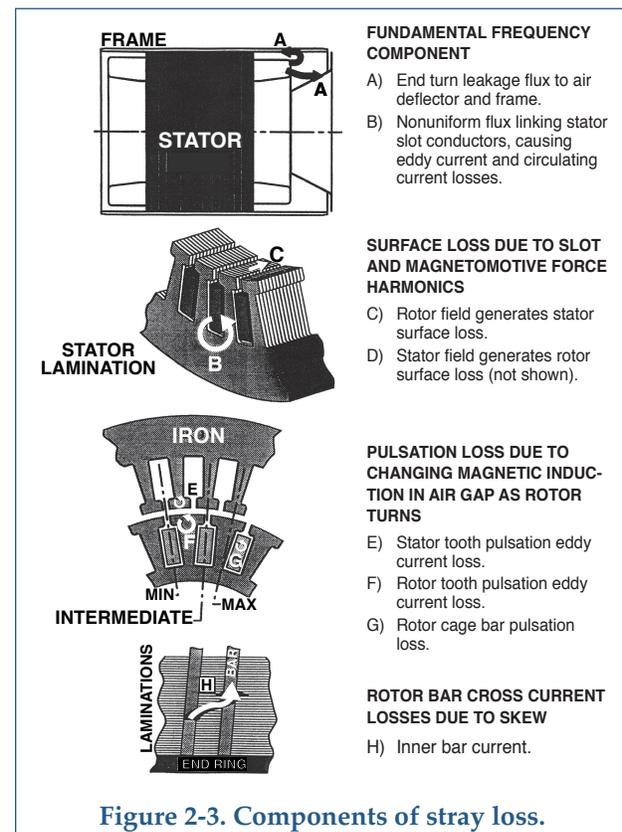
**Figure 2-3. Components of stray loss.**

The stray load losses for the motors in Group A of the study increased significantly. The cause was the mechanical damage done to the stator core (i.e., flared ends of lamination teeth) in removing the old windings and slot insulation. This, in turn, increased the pulsating or zig-zag losses. (See Figure 2-3 to learn more about the components and effects of stray loss.)

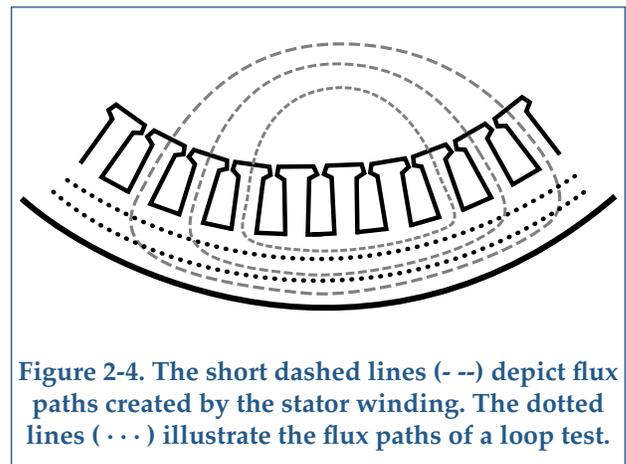
**Figure 2-4.** The short dashed lines (- - -) depict flux paths created by the stator winding. The dotted lines (· · ·) illustrate the flux paths of a loop test.

**Loop test.** The loop test (also called the ring test) is a core testing technique primarily intended to detect hot spots (i.e., localized areas where interlaminar insulation is damaged) in a stator core. Calculations of the number of loop turns required for a desired core magnetizing flux level are made with a target flux level of 85,000 lines per square inch (85 kl/in<sup>2</sup> or 1.32 Tesla) being common. Some service centers calculate the loop turns required to magnetize the stator core to the core flux level of the winding design, calling this a “full flux” core test. The distribution of the flux induced in the core by the loop test, however, is not the same as that induced by the machine’s winding, particularly when the rotor is removed (see Figure 2-4).

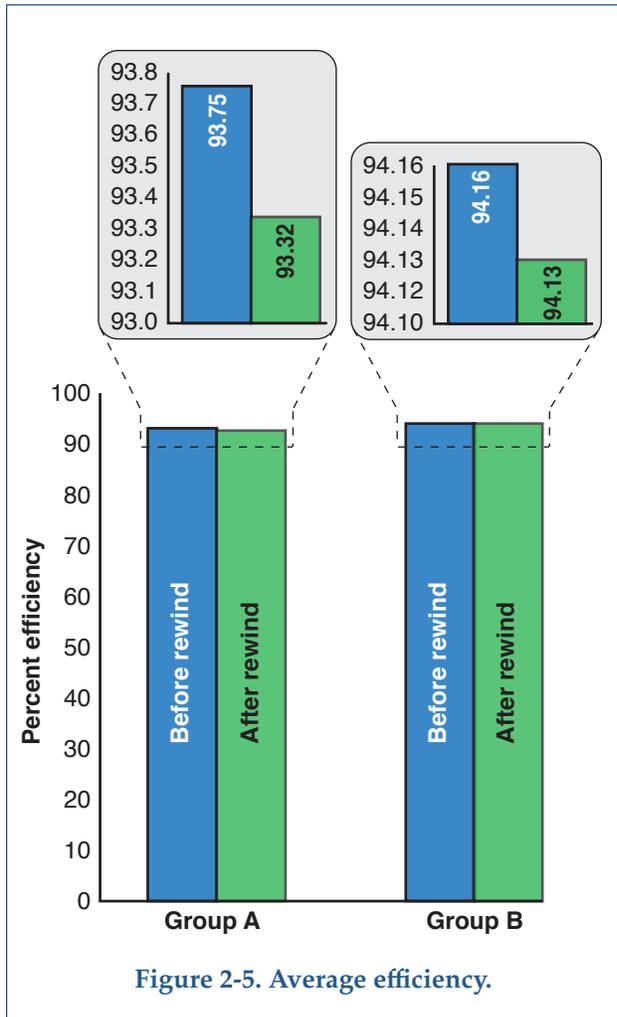
**Figure 2-5. Average efficiency.**

The average efficiency change for each controlled group also falls within the range of accuracy for the test method ( $\pm 0.2\%$ ), showing that motors repaired /rewound following good practices

All motors were burned out at controlled temperatures. Other specific controls applied to motors (except those in Group A) included control of core cleaning methods and rewind details such as turns /coil, mean length of turn, and conductor cross sectional area. The benefits of these controls, which are evident in the results for Group A and B motors in Figure 2-5, formed the basis of the good practice guide prepared by EASA and AEMT.
